Soaring Digest July 2014 Vol. 31, No. 7

4 After the Crash

A comprehensive example of what can be done to rebuild crash damage and the information which can be derived from an analysis of the damage. Chuck Anderson

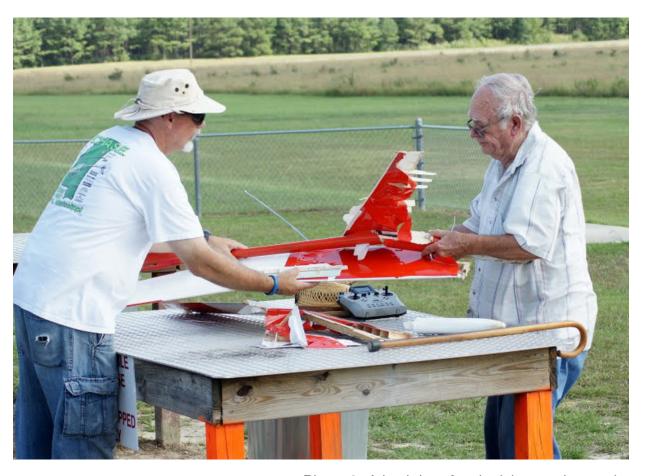
Photo 2: A bad time for decisions to be made.

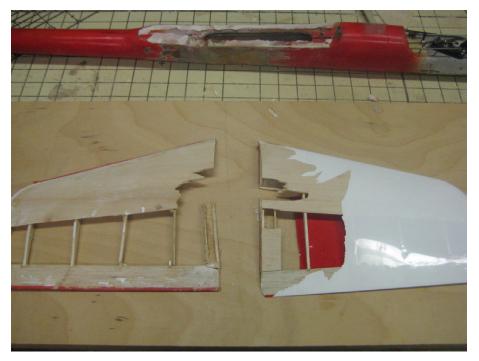
Photo 3: The damage to the fuselage and wing tips.

The right stab and the right wing tip panel were the pieces that flew off the model in the tumble. (See Photo 3) The left stab was still attached to the fin by the Monokote and the photos show it folded down in the spin.

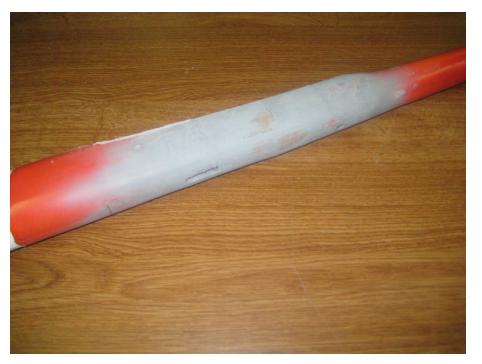
Examination of the broken parts revealed that only the center wing panel and the stabs were totally destroyed. The fuselage was broken between the wing bolts and held together by the pushrods and antenna tube with no other damage.

Photo 4: Fuselage repair.

To prevent further damage, the fuselage was jigged up on the workbench to align the parts and glued together with thin CA and 5 minute epoxy. This made the fuselage strong enough to grind the paint off the break and reinforce it with inch wide glass tape.

After the epoxy had cured overnight, the area around the break was sanded to bare fiberglass and a 4 inch wide strip of 6 oz glass laminated over the damaged area. (See Photo 4)

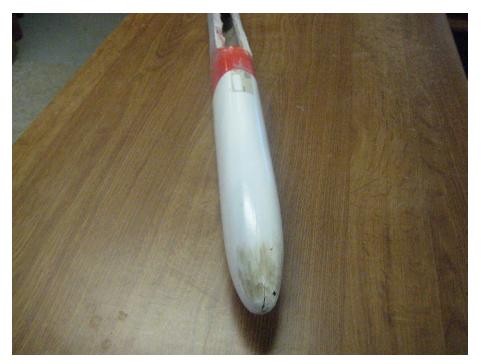
The nose cone had light scratches and needed only a little epoxy in the splice seam and paint. (See Photo 7)

Photo 7: Nose cone damage.

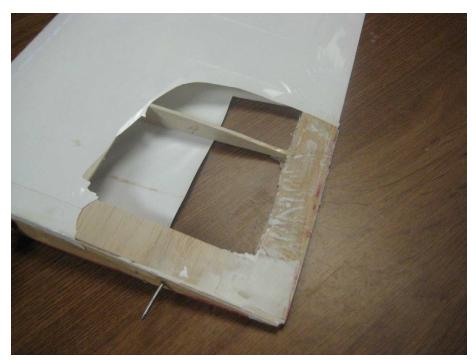
The right tip panel broke off in the snap roll and the only damage to the right outboard wing panel was a grass stain where the tip contacted the ground and a compression fracture to the trailing edge at the root. (See Photo 8)

Photo 8: Right wing panel root repair.

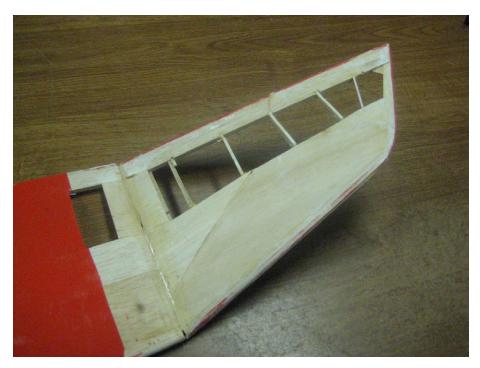
The tip panels were not designed for negative loads, so the right tip panel failed downward and sheared off in the tumble with minimum damage. The left tip panel remained attached to the outboard wing panel and suffered moderate damage when the model impacted the ground. Both were repaired and glued back to the outboard wing panels.

The tip panels were glued to the outboard panels without dihedral braces and reinforced only by a narrow strip of lightweight glass cloth on the bottom. (See Photo 9) After examining the damage, I decided that the joint was adequate

Photo 9: Left wing tip repair.

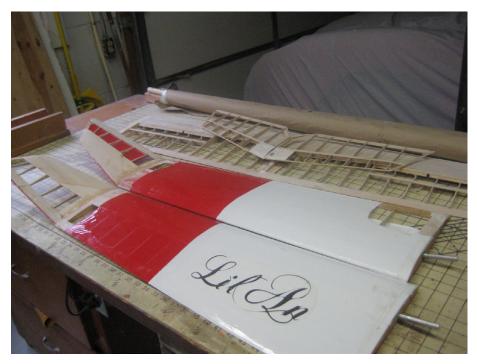
Photo 10: Wing repaired complete, waiting for recovering.

New stabs and a new center wing were built using joiner tubes, spoilers, spoiler string guide tubes, bolt beam, and plywood parts salvaged from the broken center wing panel. (See Photo 10) No structural changes were found necessary from the crash analysis; however changes were made in the build sequence to make the wing easier to build.
